# CW operation of high-current deuteron injector for the Linear IFMIF Prototype Accelerator (LIPAc)

International Conference on Ion Sources 2025 (ICIS'25)

LIPAc Injector and commissioning overview

Investigation of BN disks degradation

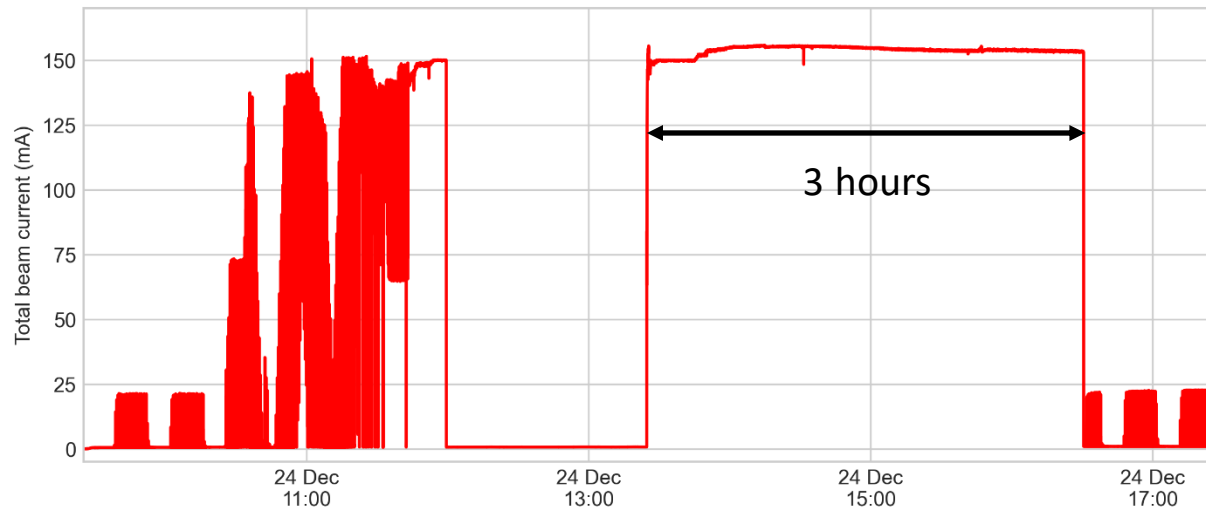
The total extracted current at CW was gradually increased up to 155 mA.

### Beam parameters:

- $\epsilon_{rms,n} = 0.18 \pi \cdot \text{mm} \cdot \text{mrad}$
- $I_{ext} = 155 \text{ mA}$
- $\langle I_{FC} \rangle = 148 \text{ mA}$
- rms noise = 1.7%
- Species fraction = 92%

✓ Meets LIPAc requirements

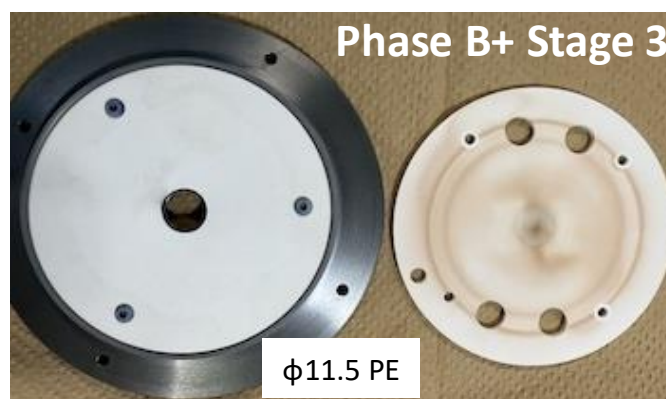
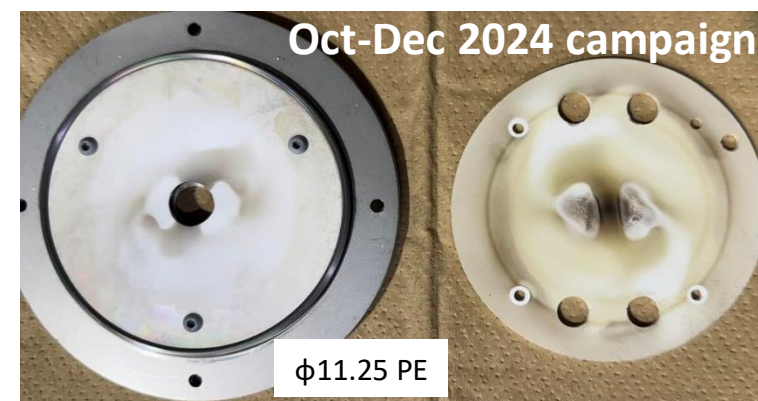
## Total amount of extracted charge from the source

**Most severe level of degradation**

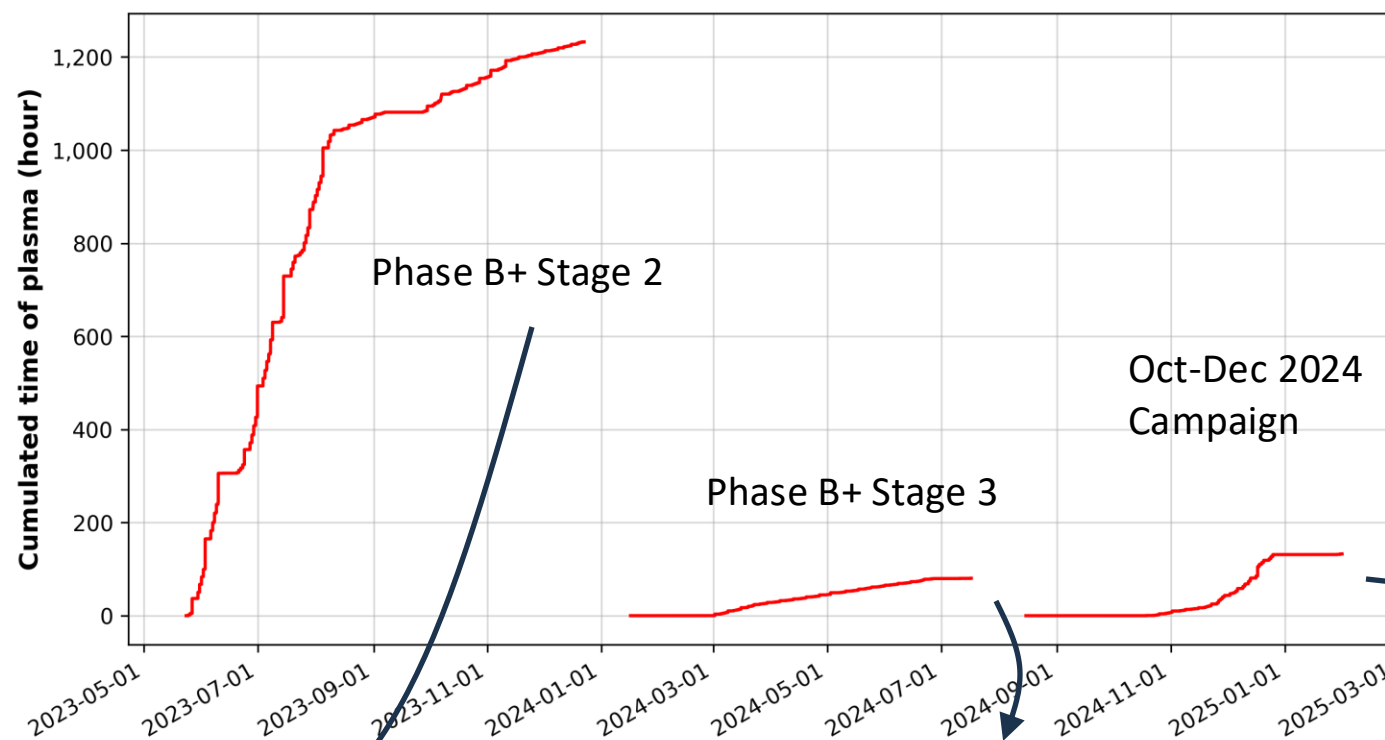
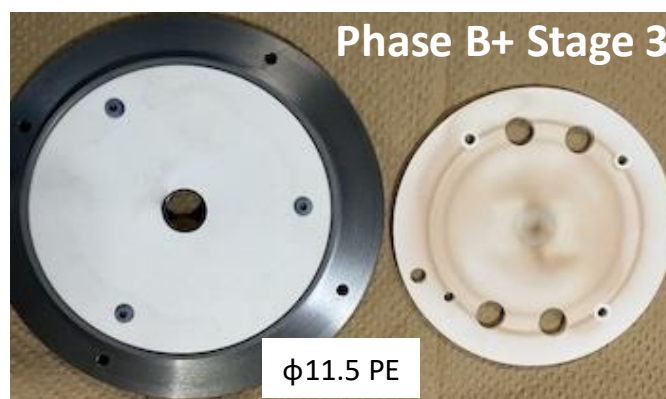
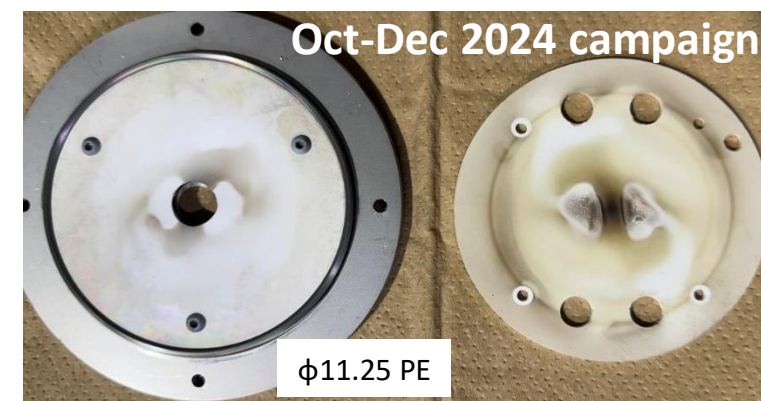
## Cumulated time of plasma in the source with the BN disk degradation level

At LIPAc, the beam is typically not extracted during night. Instead, “plasma conditioning” is performed.

The significant difference in the cumulated time of plasma is due to differences in the duty cycles of the plasma conditioning.

**Most severe level of degradation**

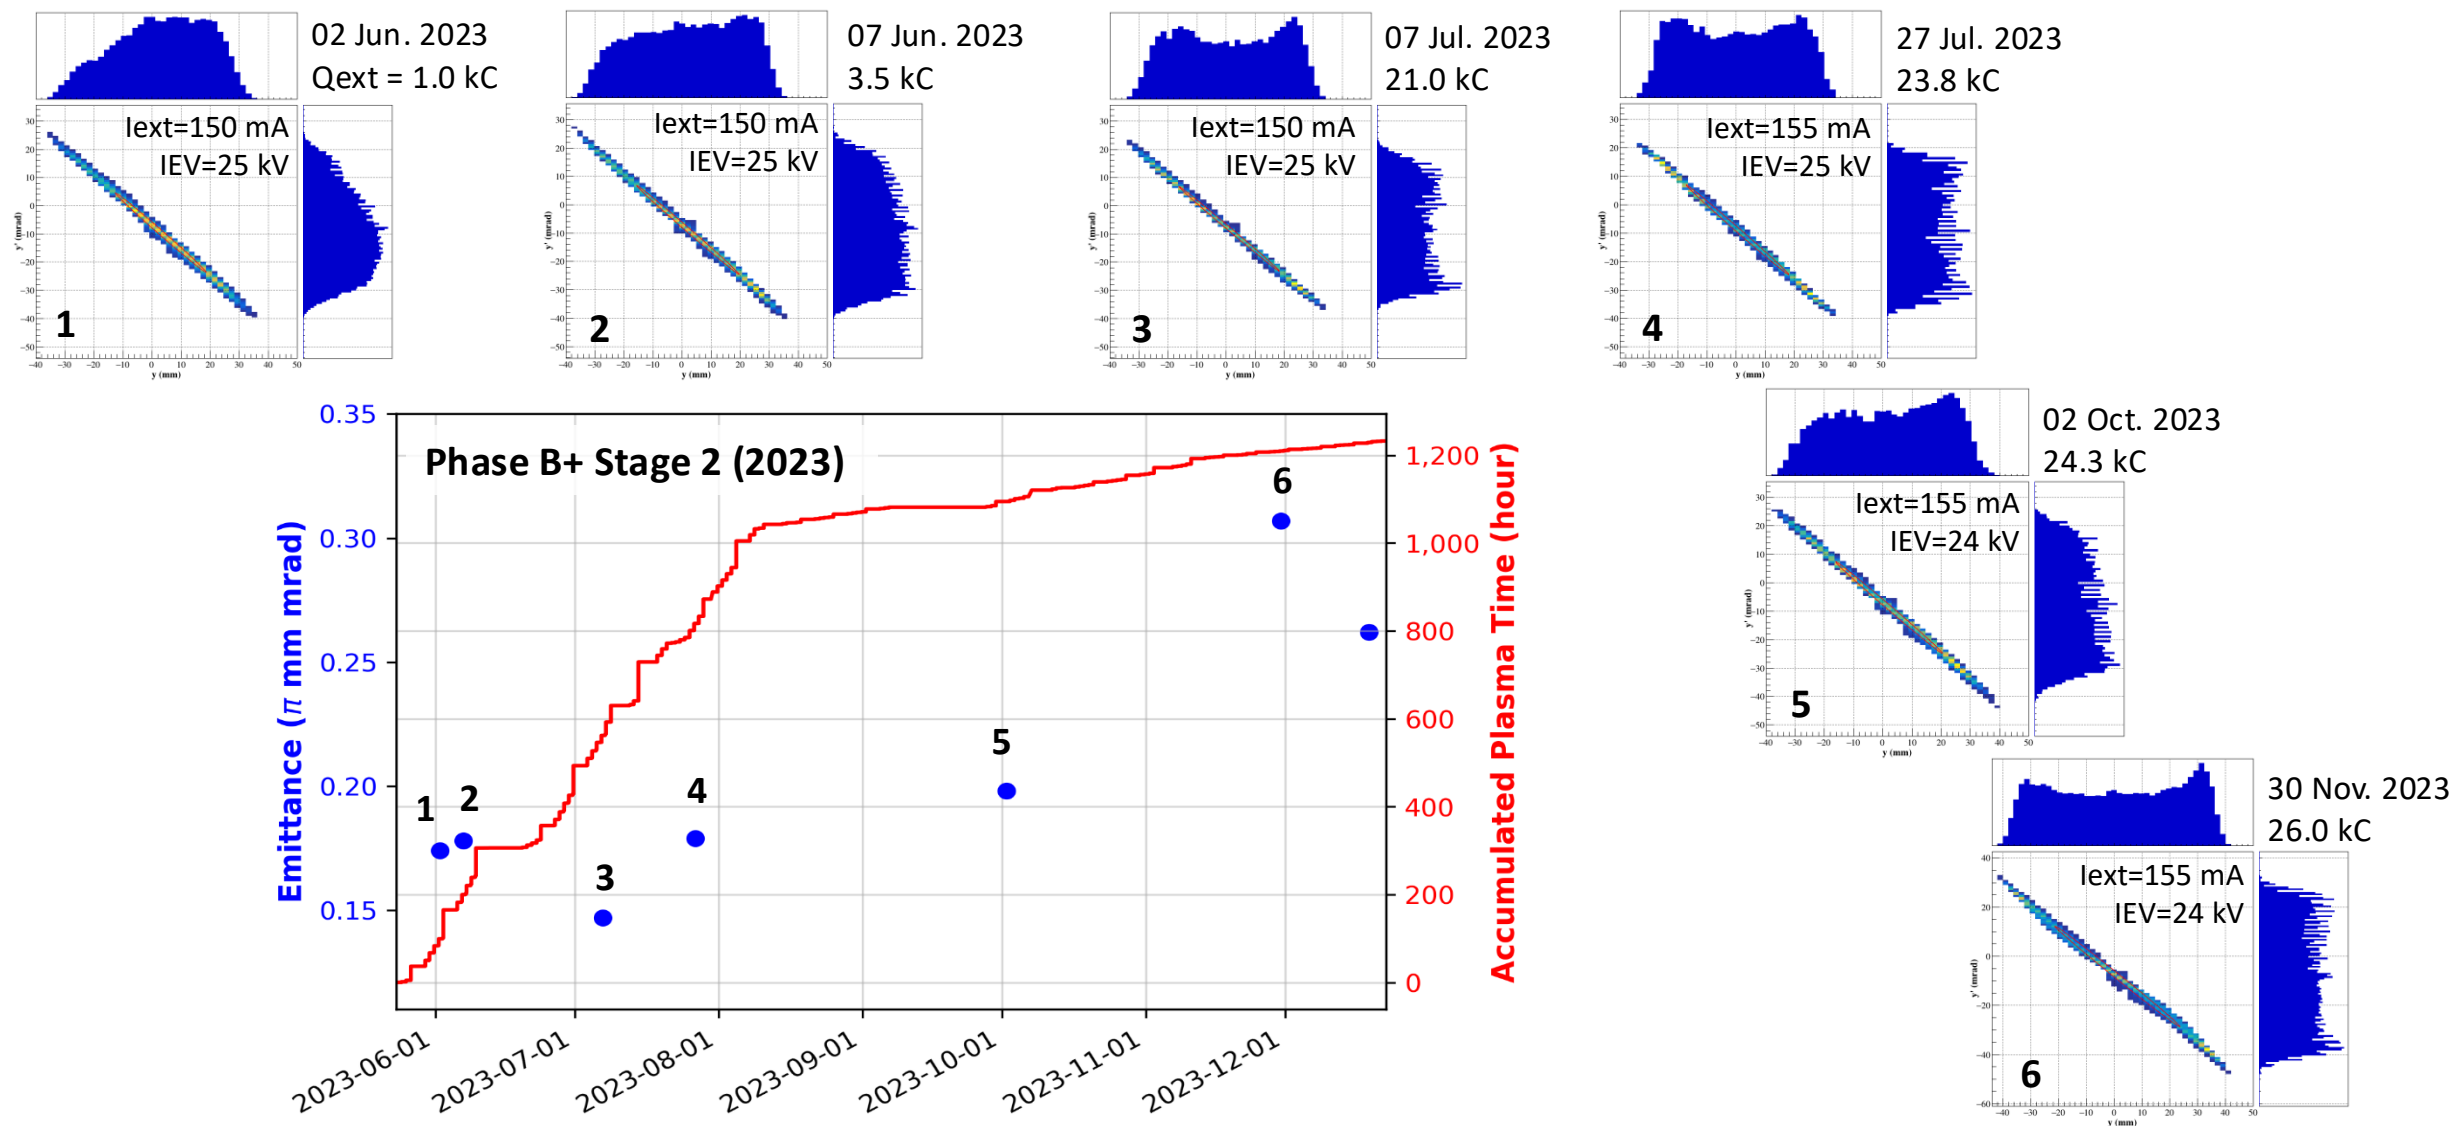
## Cumulated plasma time also correlates with the degradation of beam quality

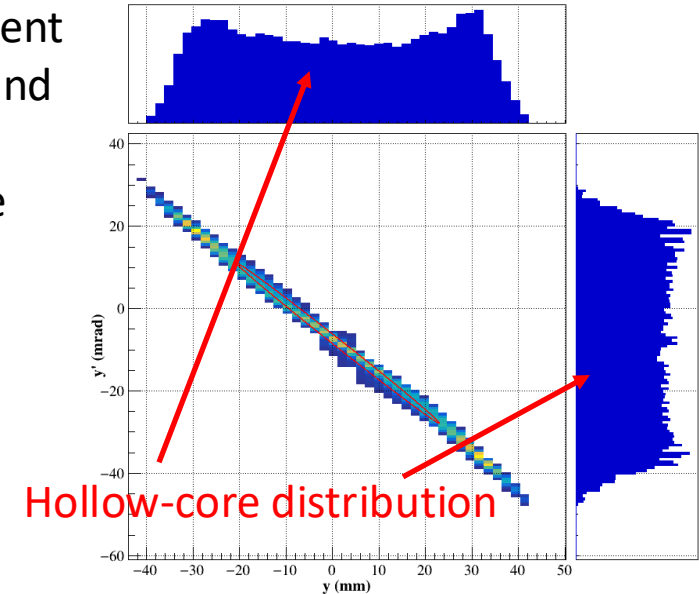
## Experimental confirmation of correlation of BN disks degradation vs. beam quality

- During Oct-Dec 2024 campaign, additional measurements were conducted by replacing the BN disks with the severely degraded ones used during Phase B+ Stage 2.
- The phase space distribution and the emittance are well reproduced by using the degraded BNs.
- **These results allow to conclude that the degradation of beam quality is directly related to the condition of the BN disks.**

Dec. 2023

$0.26 \pi \text{ mm.mrad}$

$I_{\text{ext}} = 150 \text{ mA}$

Jan. 2025

$0.19 \pi \text{ mm.mrad}$

$I_{\text{ext}} = 156 \text{ mA}$

BN disks replacement  
(RF and PE side) and  
operation with  
identical source  
parameters

$0.27 \pi \text{ mm.mrad}$

$I_{\text{ext}} = 151 \text{ mA}$

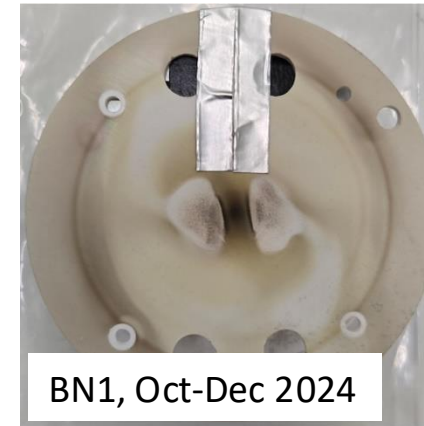
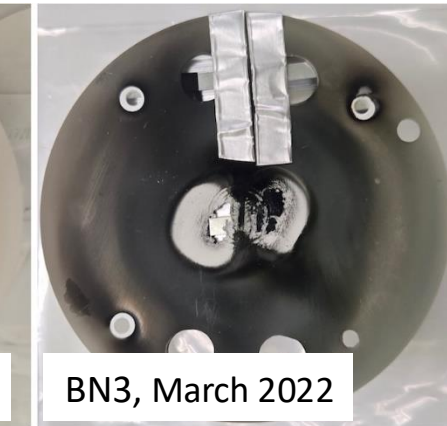
## 2) Investigation of underlying mechanism of degradation: BN disks surface analysis

Results of the EDS analysis show presence of contaminants:

Disk	Degradation Level	Detected Elements	Comment
BN1	Least	B, N, Fe, Ni, O	Screws, H <sub>2</sub> O
BN2	Moderate	+ C	Increased contamination
BN3	Severe	+ Cu	Cu exposure due to perforation

- The areas of severe BN disk degradation (sputtering) correspond to locations where Cu (ridged waveguide) is present behind it. Why is that?
  - 1) Different charge-up due to conductivity change (e.g., with temperature)?
  - 2) RF modes & plasma heating process?
  - 3) ???

Cumulated

plasma time: 130 hour

1200 hour

4400 hour

- Some contaminants come from screws → cover screw heads with ceramic caps.
- Contaminated layer might absorb RF power → monitor temperature of the plasma chamber in future campaigns.

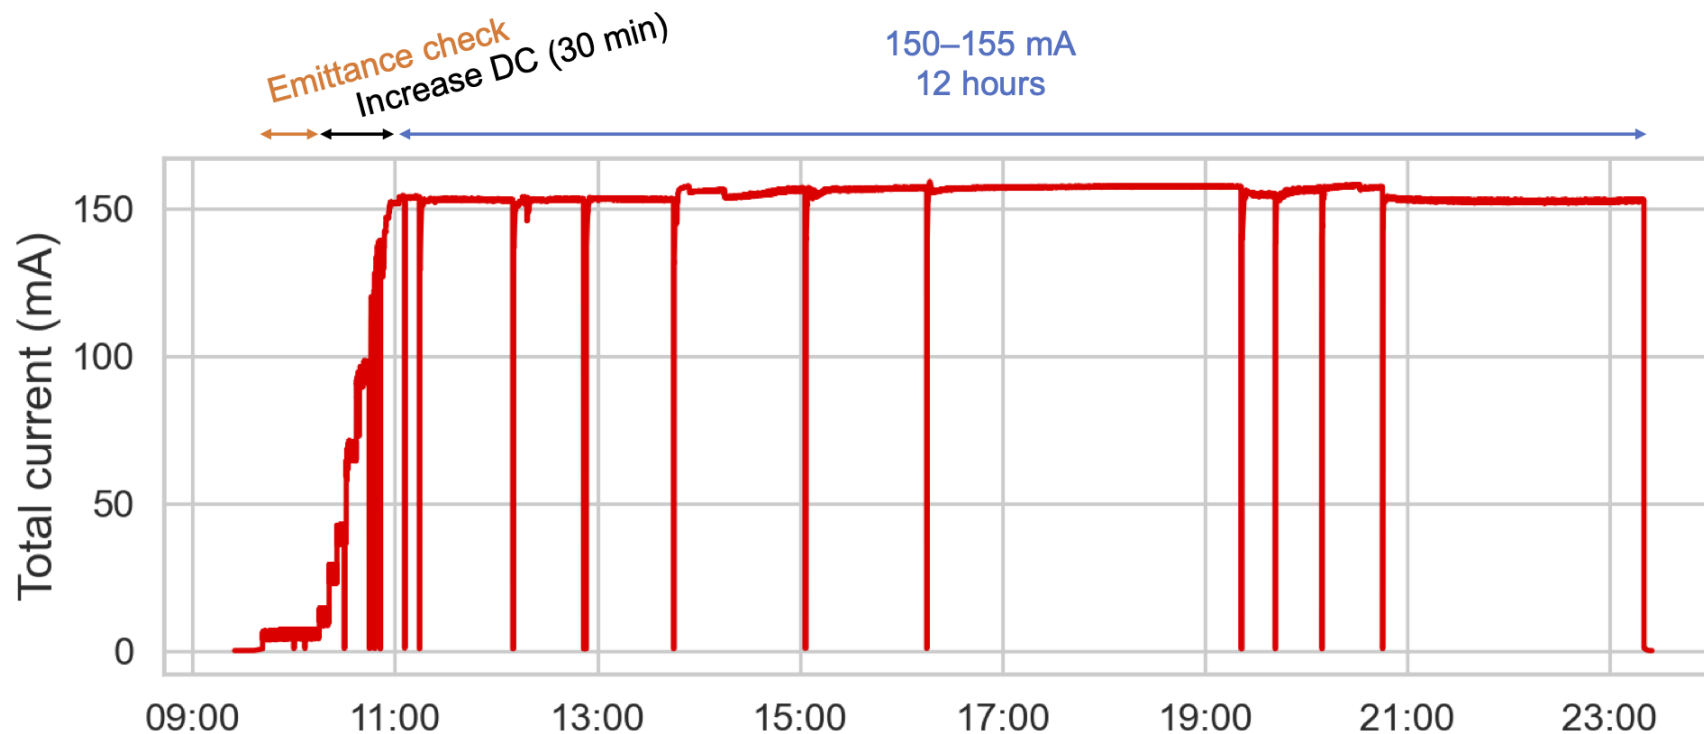
## CW 12-hour-long run with $\phi 11$ -mm PE:

- Total extracted current 150 mA, D+ fraction fraction 91%, emittance  $0.24 \pi$  mm mrad.
- CW long run operation with this beam condition.

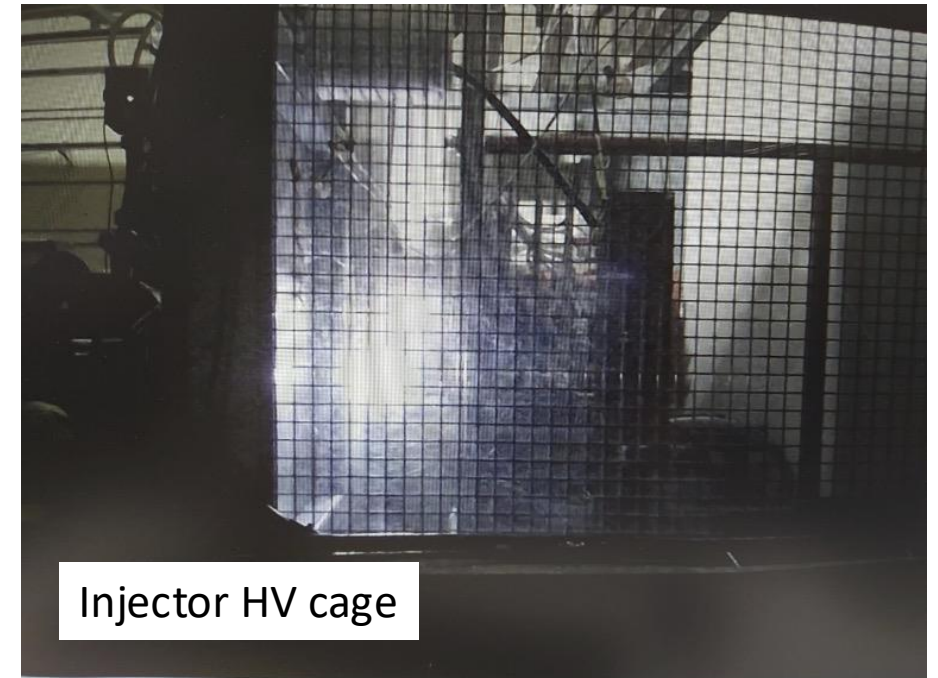
Injector HV cage

**Corrective action for the sparks issue was conducted before CW long run.**

**Installation of braided wires has eliminated sparks that occurred on the outside.**

It's important to eliminate empty spaces, even if two parts have the same potential.

Location of sparks were identified with camera.

Flat Braided wire

Flat Braided wire  
(HV potential)

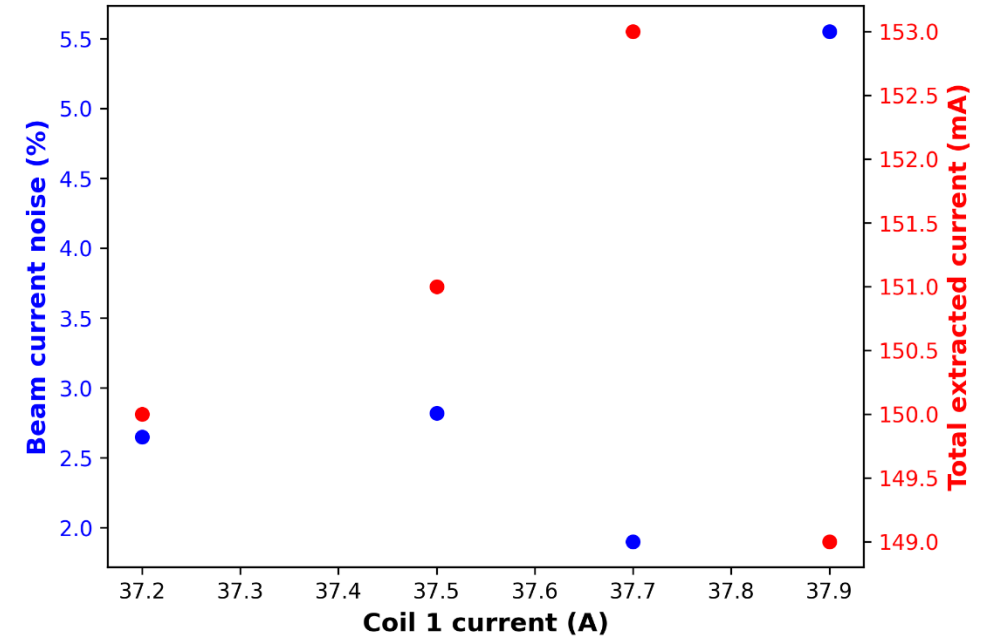
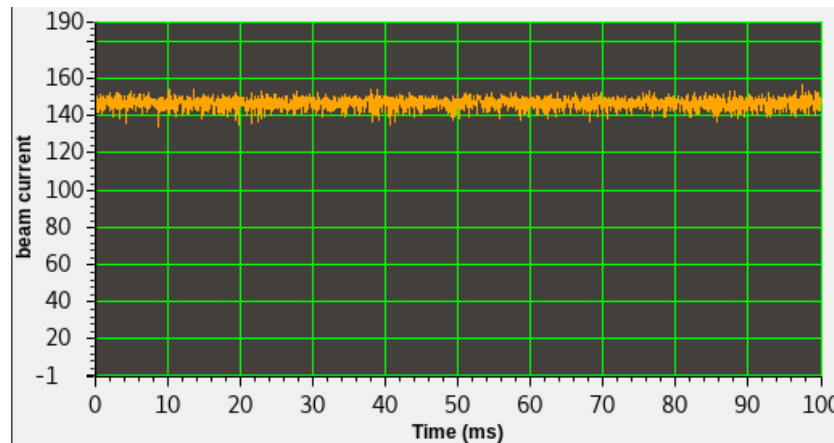
## Beam current noise optimization

Source coil 1 current has large impact on the total extracted current and beam current noise.

Coil 1 current (A)	37.2	37.5	37.7	37.9
I_ext (mA)	150	151	153	149
I_FC (mA)	144	145	146	143
I_FC rms noise (%)	2.65	2.82	1.90	5.55

Coil 1 = 37.5 A

Coil 1 = 37.7 A

Coil 1 = 37.9 A
