ITER CS Inlet Fatigue Test

ICMC

09/02/2018

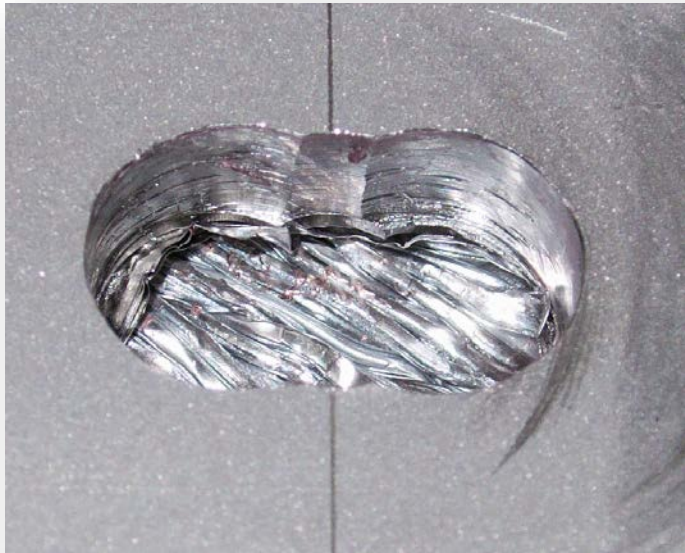
Inlet features

The oblong hole is made by three overlapping round holes

The highest stress and highest B – lowest Tcs
60 kcycles in operation

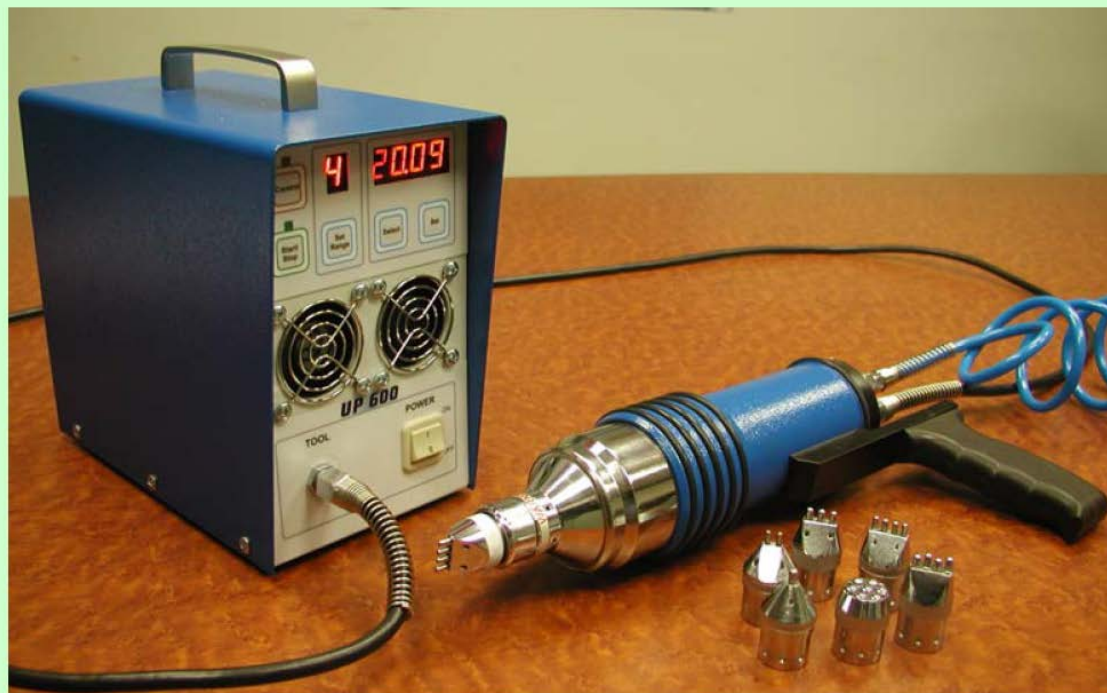
Basic UP system for fatigue life improvement of parts and welded elements

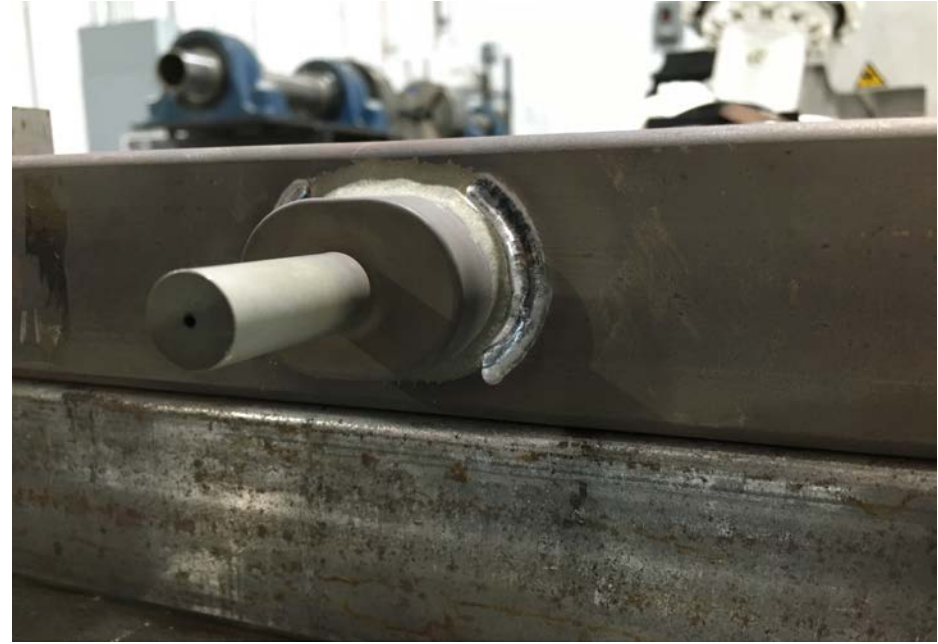
Concern will UP damage the superconductor?

Study showed – UP does not damage the superconducting properties

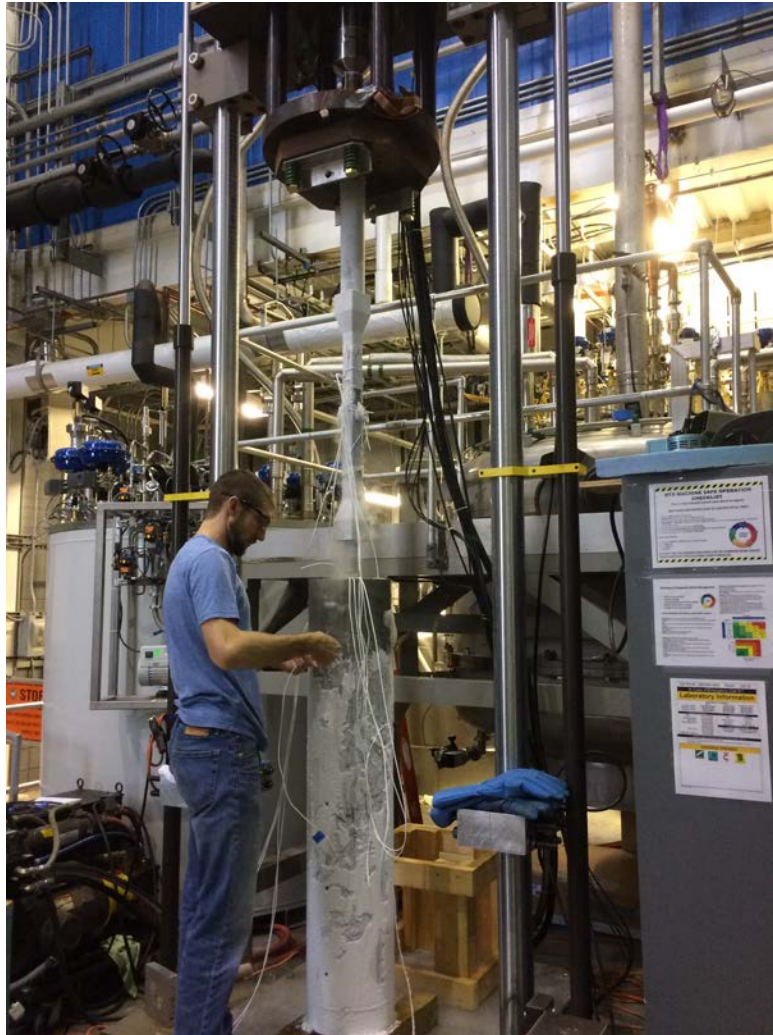
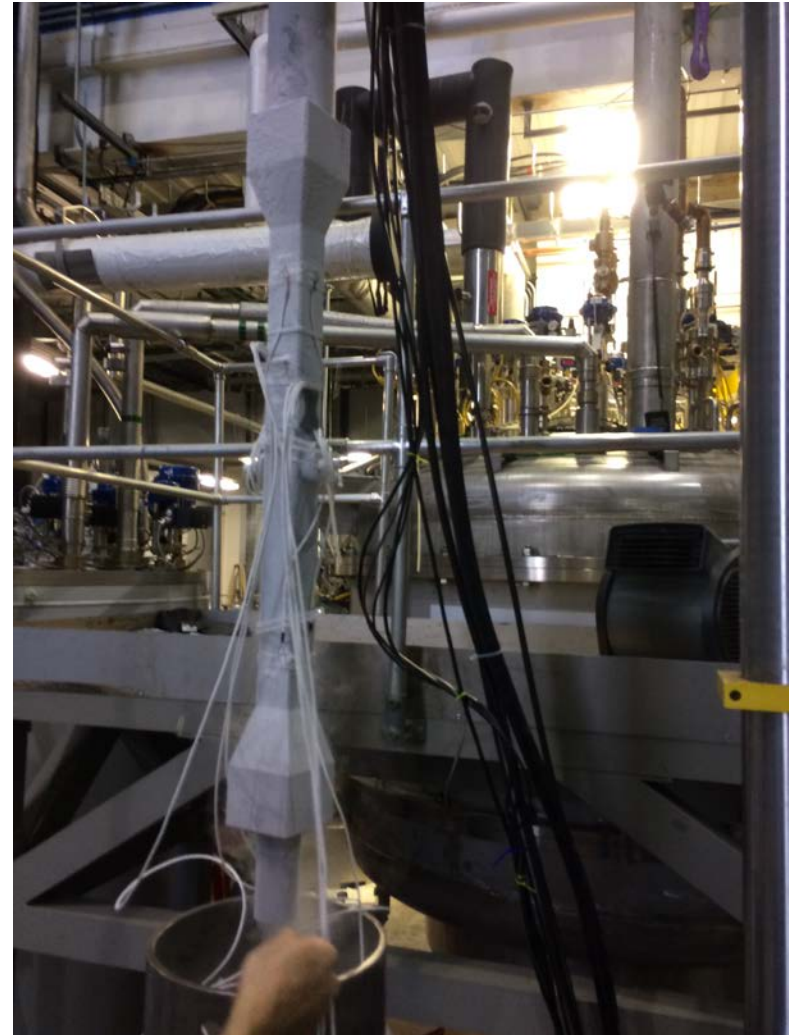
Strain gauge instrumentation

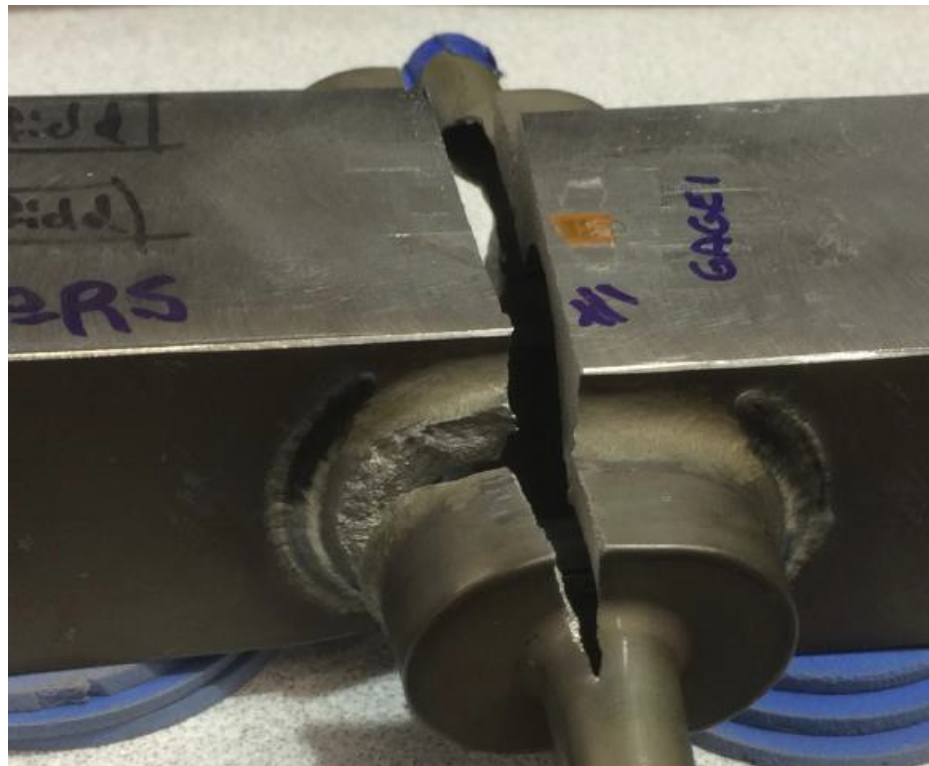
UP treated failed after
534.5 kcycles at the
drilled hole

| Condition | Sample ID | Max force, kN | Max fatigue stress, MPa | Nominal fatigue stress range, MPa | Cycles to failure | Comments |
|---|---|---|---|---|---|--|
| | 5-P-RS | 434 | 336 | 303 | 534,518 | Crack originated at the hole in the jacket |

- The ITER CS inlets meet requirements for fatigue testing presented in national and international structural codes
- Ultrasonic peening is a necessary condition for fabrication of the inlets with sufficiently long life for ITER CS. Ultrasonic peening extends life of the inlets by a factor of 3.5–5 or higher.
- All failures in the peened specimens were initiated in the second-highest stress location—the area where the cable space meets the drilled hole of the inlet. This agrees with the FEA and fracture mechanics predictions.
