High-Field Combined Function Permanent Magnet

Open midplane design with $>1.5\text{T}$ in
good field region, 10^{-3} field accuracy,
relevant for CEBAF upgrade

Tooling for Assembling a Permanent Magnet

Stephen Brooks, CEBAF upgrade meeting

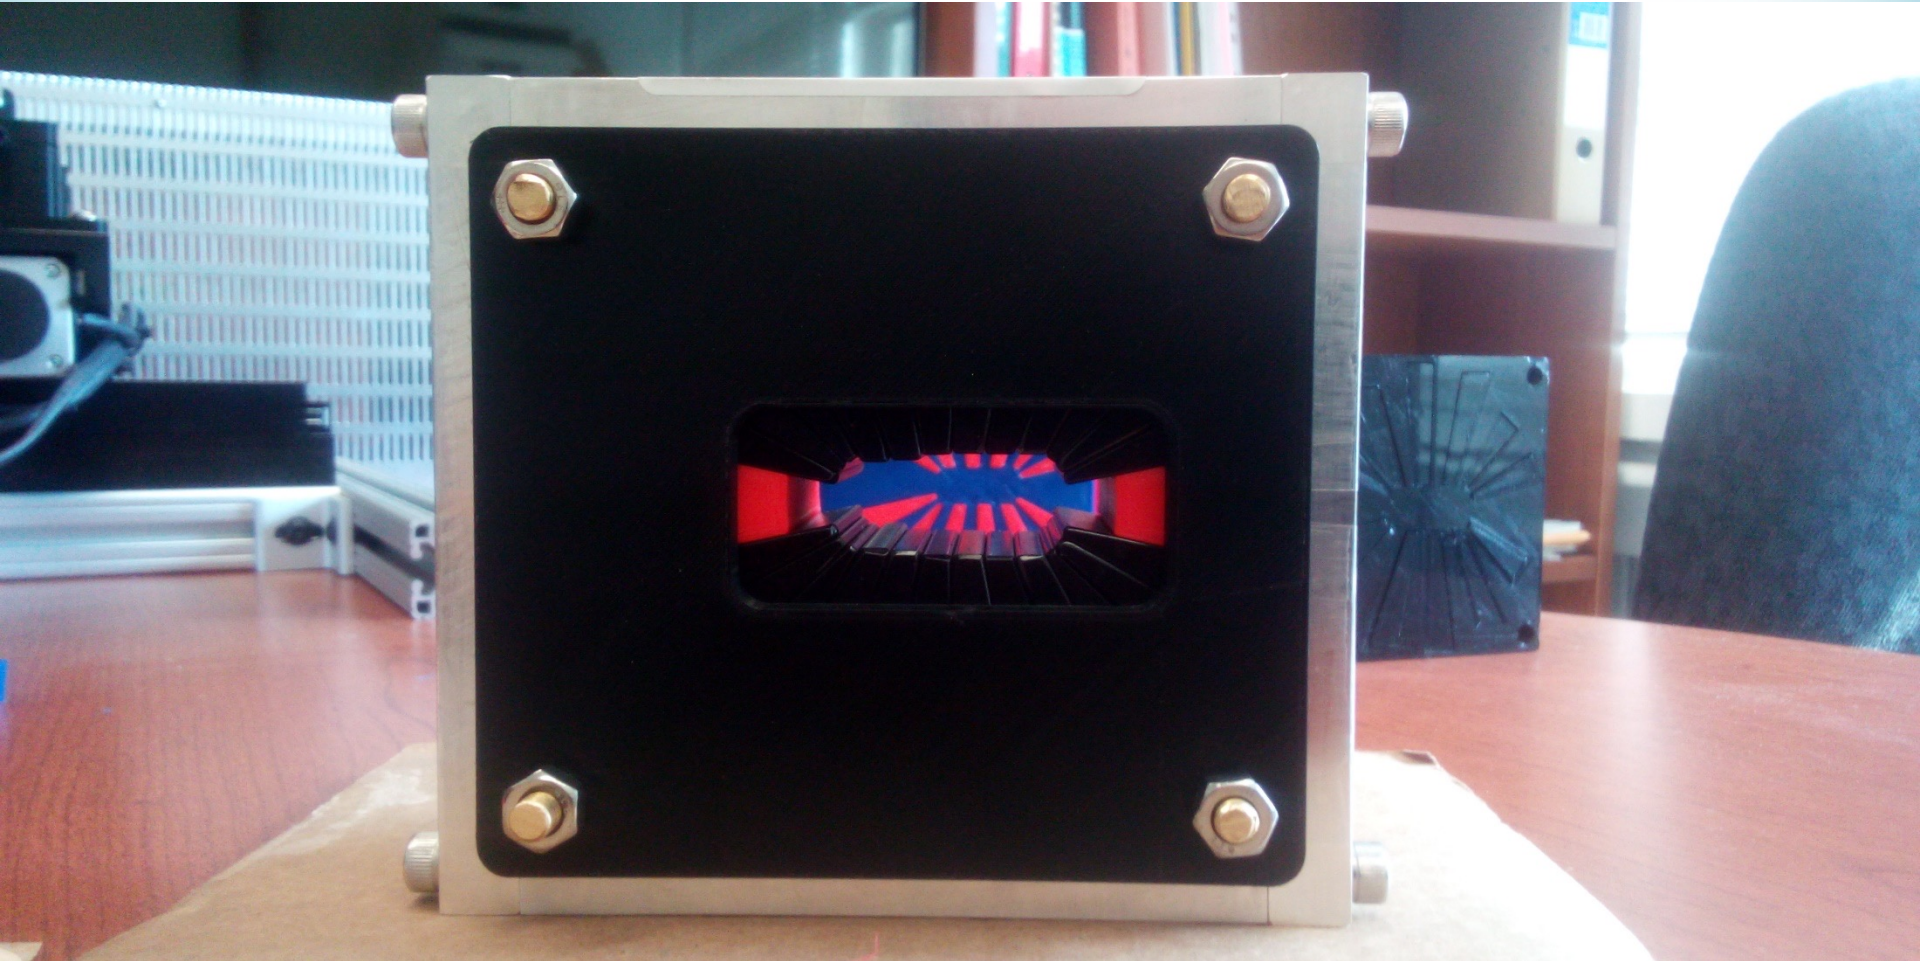
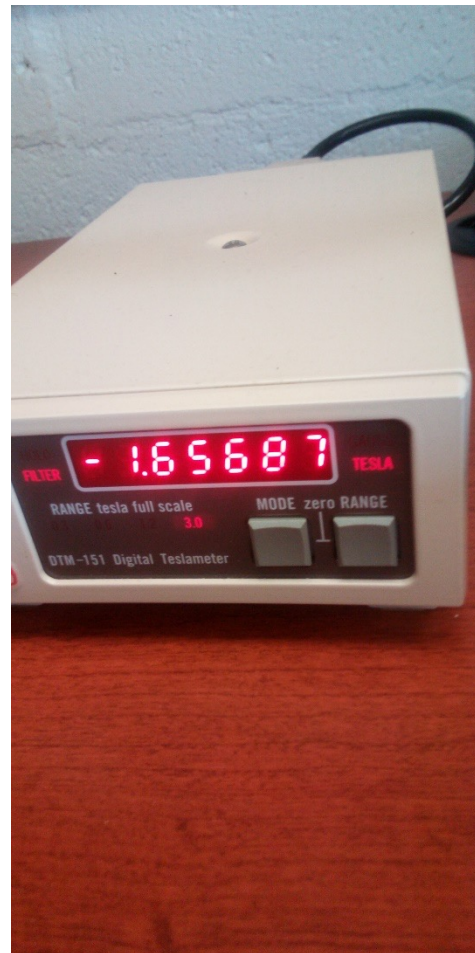
High fields exist in aperture

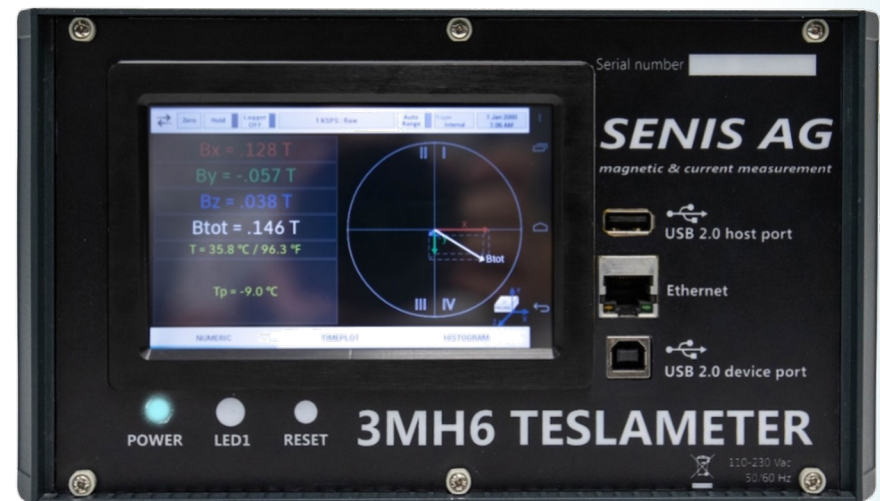
Fieldmap Measurement

- Used Senis 3MH6 teslameter with 3-axis Hall probe
 - Accurate to $\pm 0.01\%$
- Two (horizontal X,Z) linear movement stages
 - Few microns
- $\pm 10.5\text{mm} \times 200\text{mm}$
 - 0.5mm, 2.5mm steps
- 8 repeated scans

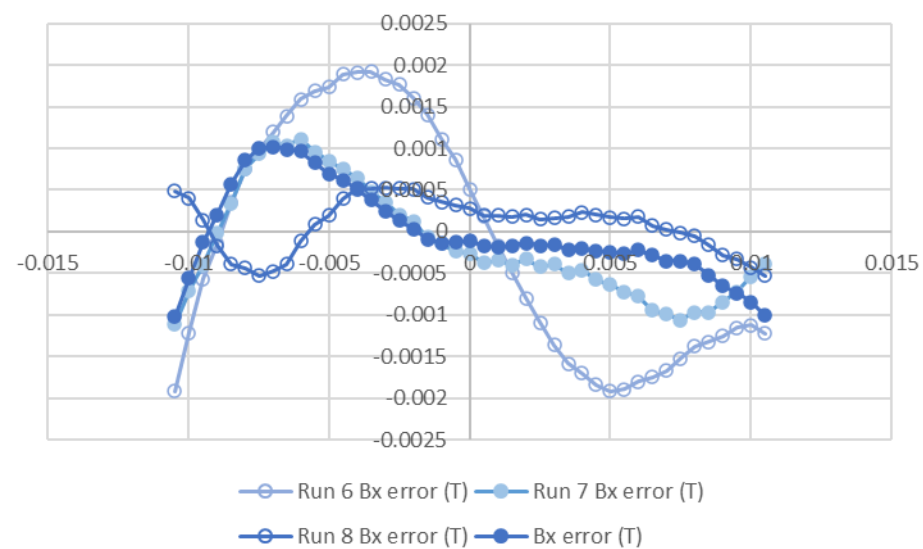
Integrated Field Error History

- Gradual improvement over runs 6-9
- Short magnets often require more iterations because of end field effects

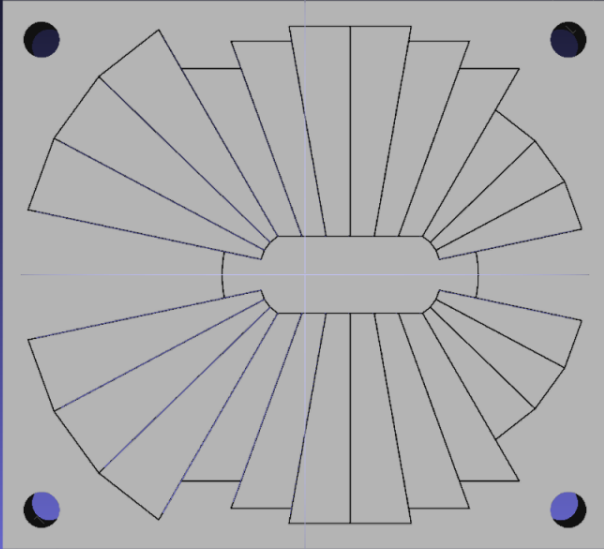
MeshLab v1.2.3b - [CEBAF_mould_filled.stl]

Full mould
all pieces and central plug, printed
double wall thickness for strength

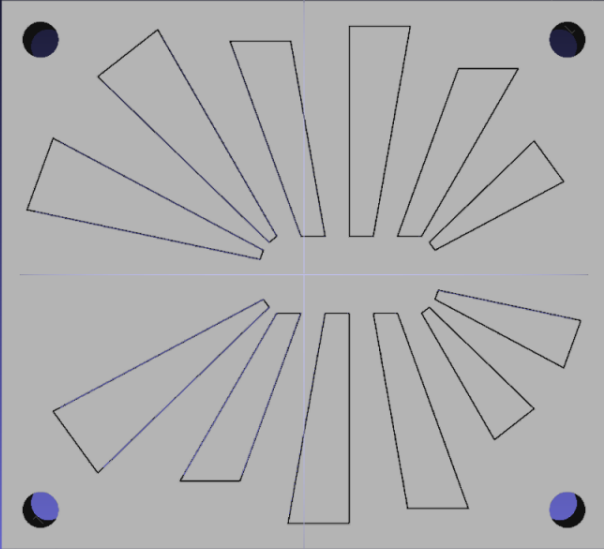
MeshLab v1.2.3b - [CEBAF_spider_filled.stl]

“Spider”
Channels for half the pieces
Can be flipped over to get other half
