Hot Liner for the Production of Metallic Ion Beams at GSI

F. Maimone, A. Andreev, M. Galonska, R. Hollinger, R. Lang, J. Mäder

ABSTRACT: At GSI, the CAPRICE ECR Ion Source (ECRIS), installed at the High Charge State Injector (HLI), delivers continuous-wave (CW) metallic ion beams for studies and experiments carried out by nuclear physics, materials research, and superheavy elements groups. To meet the demand for ions from metals and solid compounds, thermal evaporation via resistively heated ovens is employed. The use of a hot tantalum liner, inserted into the ionization chamber, has been validated for the efficient production of high charge state ion beams from rare isotopes—such as ^{48}Ca —with high intensity and low material consumption. Recent results from the latest beam run demonstrate increased beam intensity stability and reduced material consumption. Furthermore, the hot liner helps mitigate metallic buildup on ceramic surfaces, enabling stable operation at high intensities with minimal disruptions. Results from operations with ^{52}Cr and ^{55}Mn confirm the effectiveness of the hot liner in enhancing operational stability.

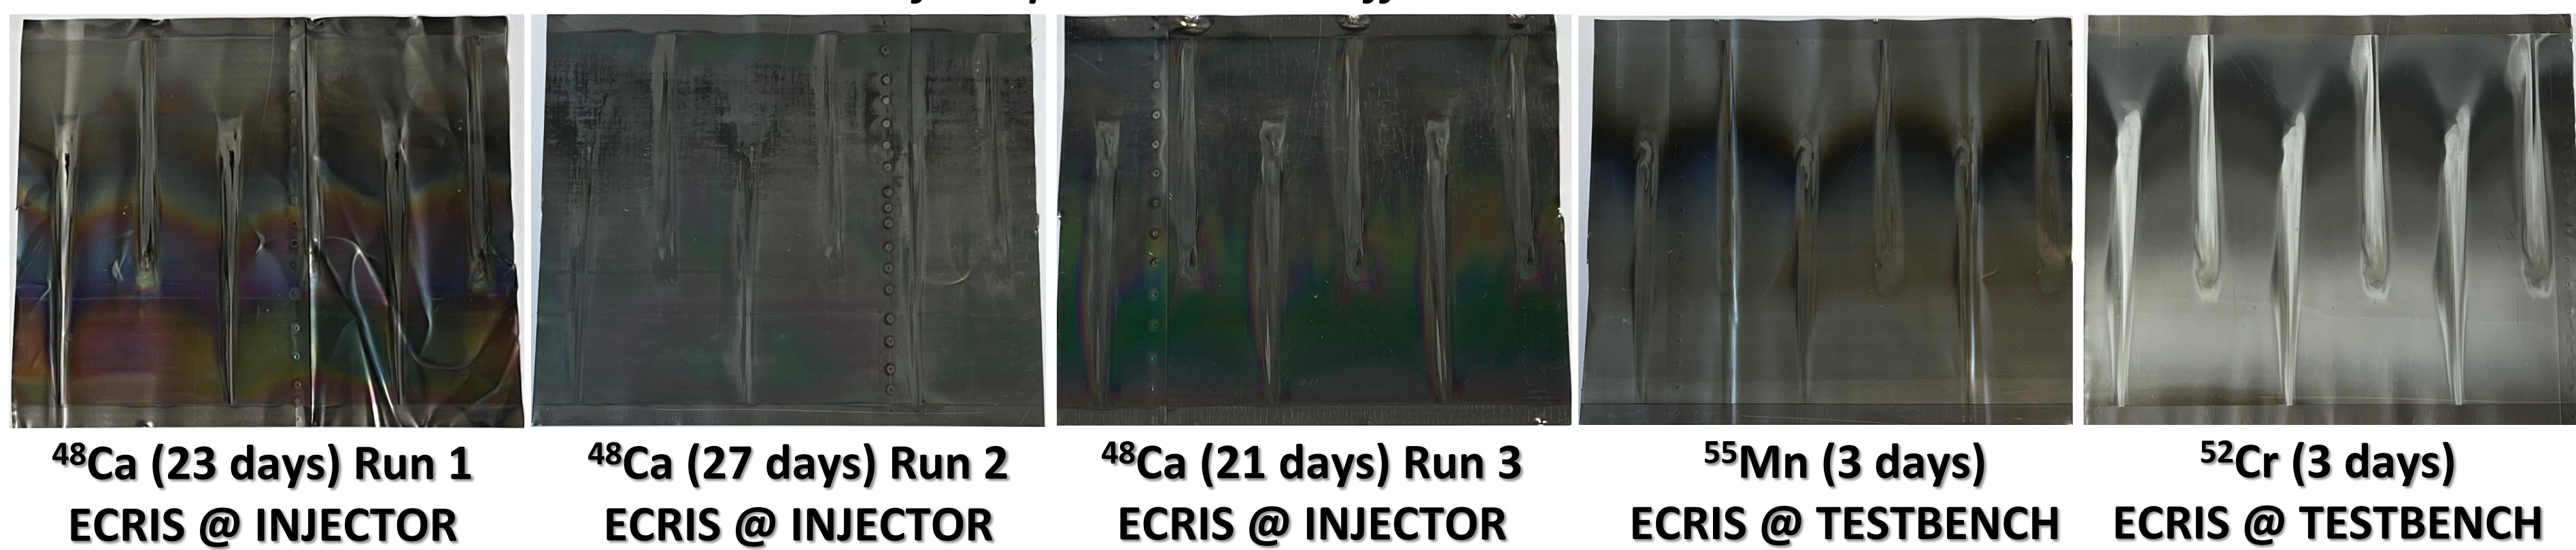
Ta liners after operation with different metallic elements

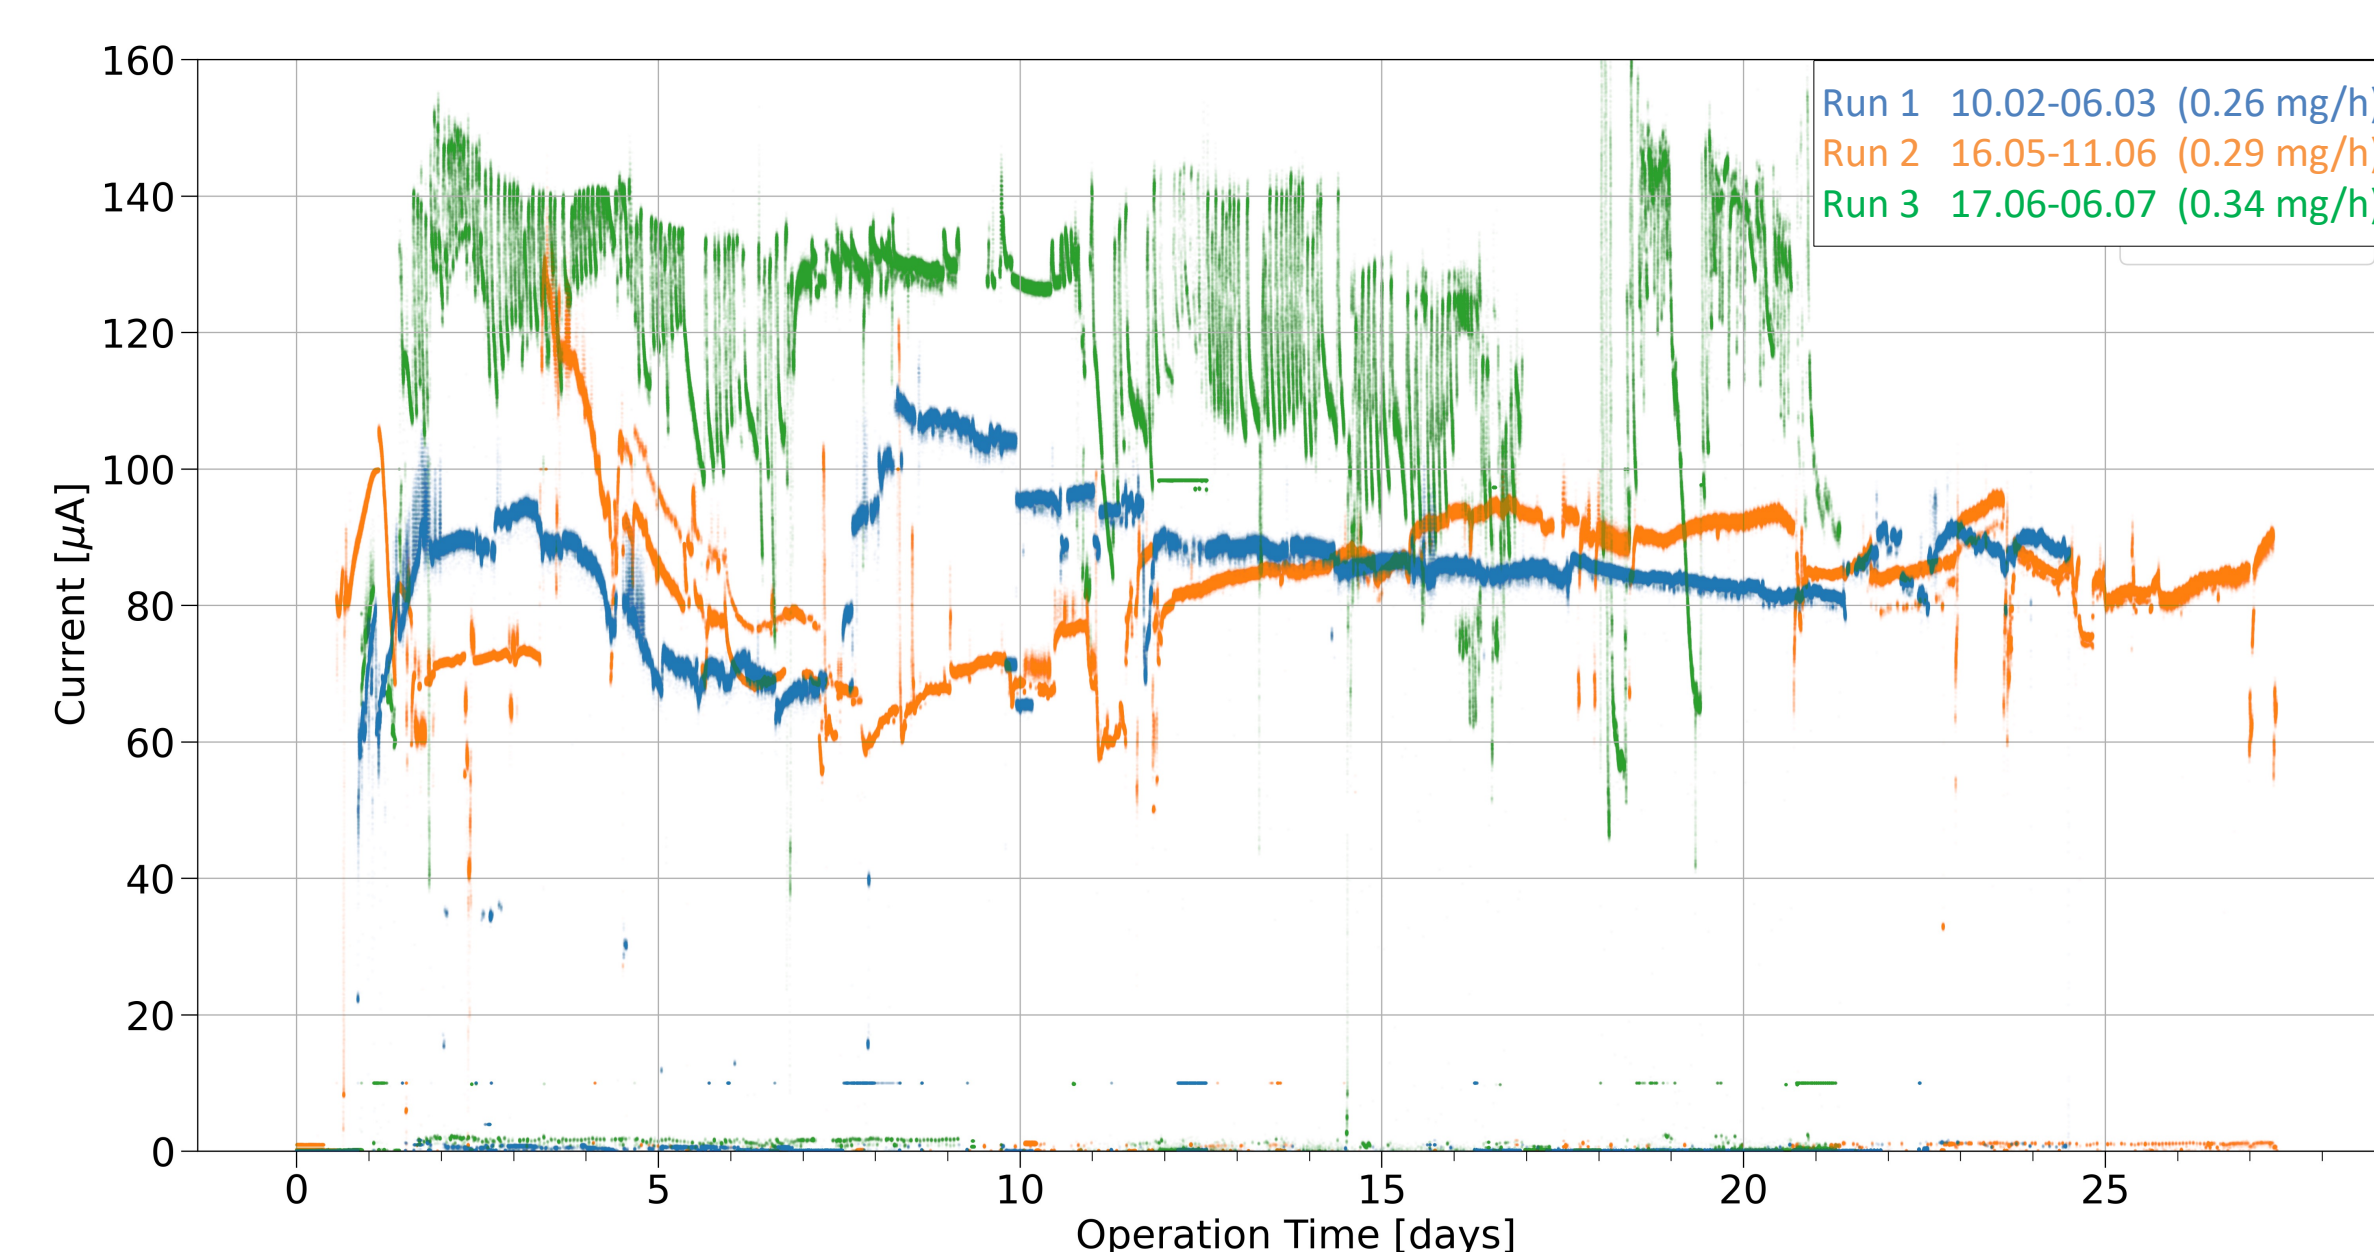
$^{48}\text{Ca}^{10+}$ ion production - beam time 2025

Intensity and stability of $^{48}\text{Ca}^{10+}$ measured at the Faraday Cup for three blocks of ^{48}Ca ion beam with the hot liner. The material consumption (with recycling) is indicated in the legend.

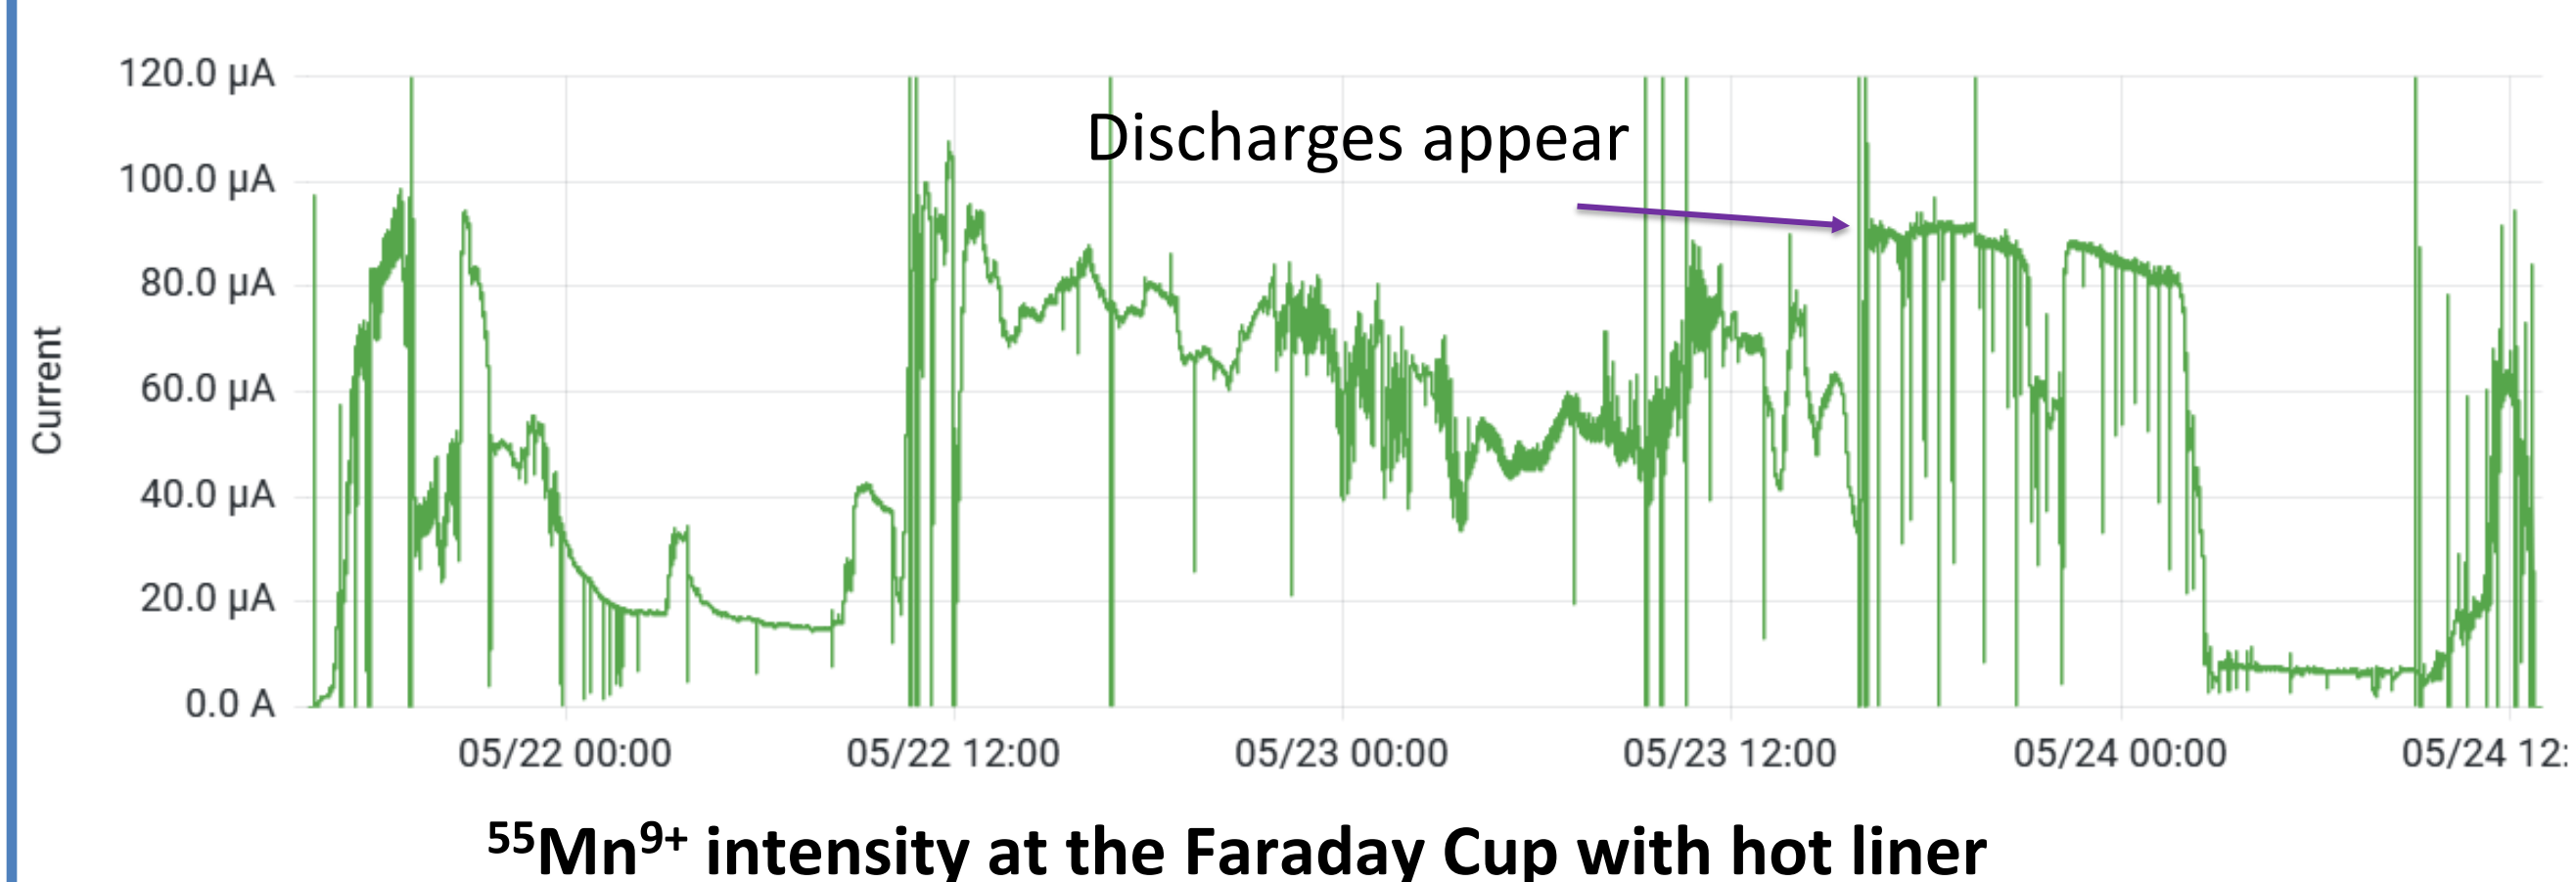
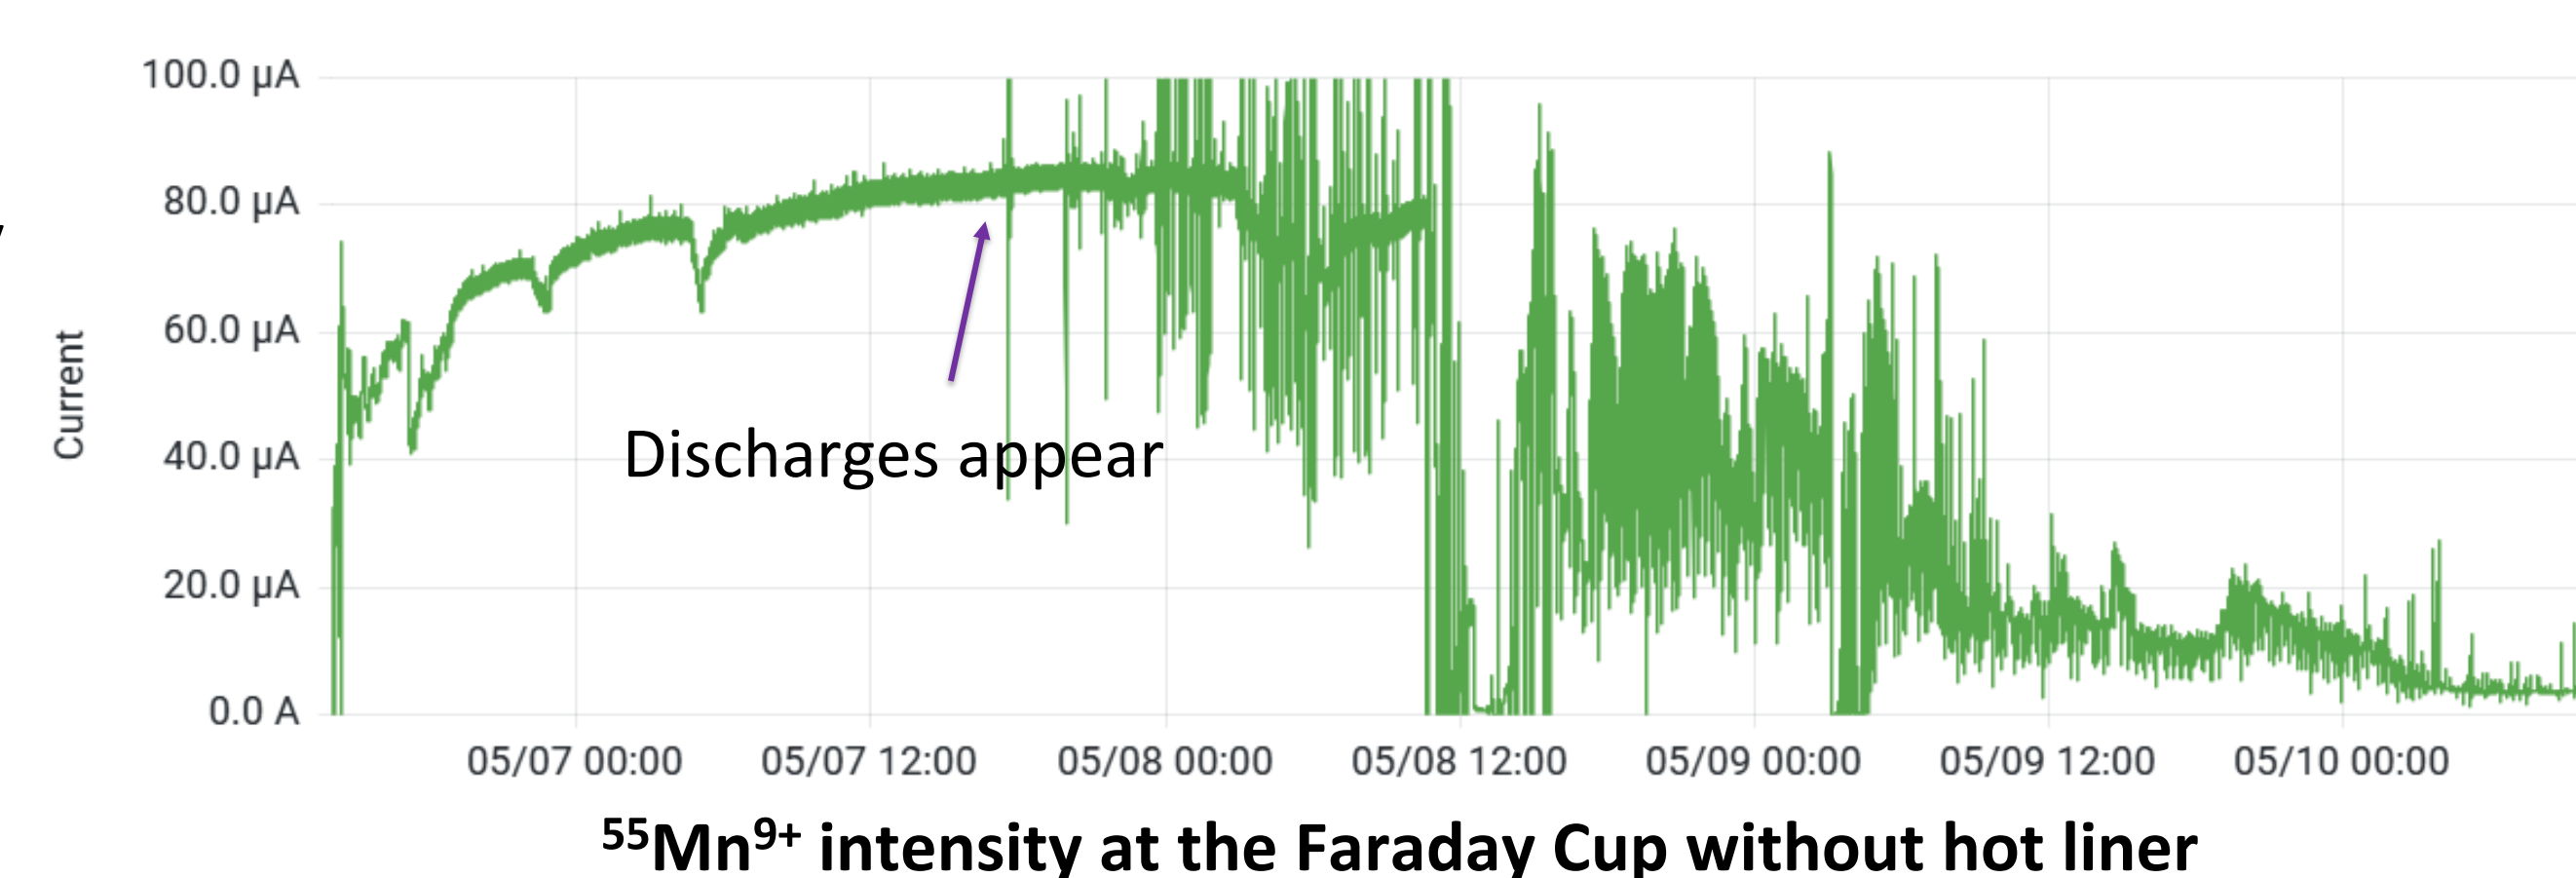
^{55}Mn stability improvement

With hot liner:

- Discharges delayed until Day 2
- Reduced discharges frequency
- Improved beam stability
- No visible traces on ceramic isolator

Without hot liner:

- Discharges started on Day 1
- Once every few minutes
- Affected beam stability

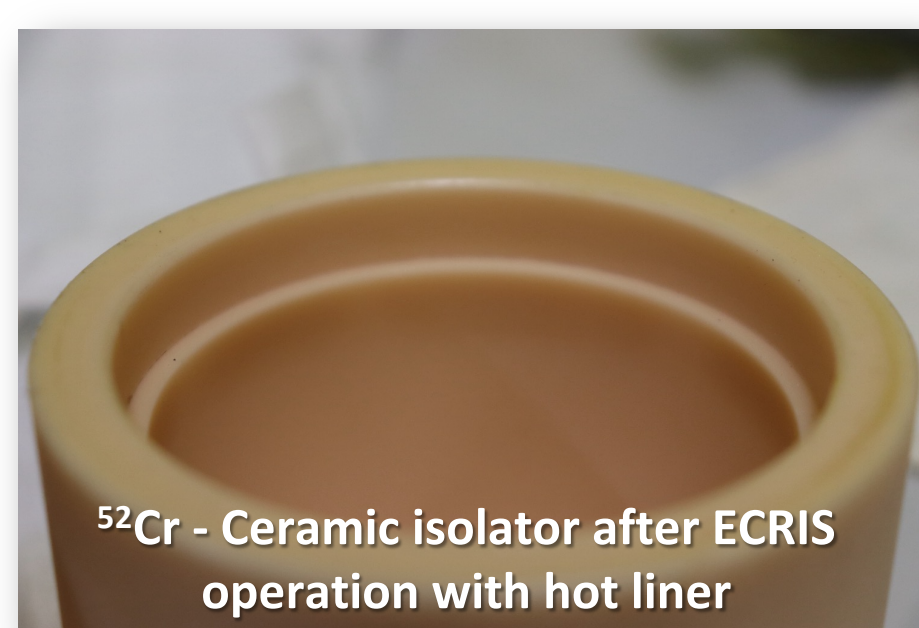
- Discharges fast build-up
- Screening and extraction power supplies affected
- Ion beam unstable
- ^{52}Cr traces and spots on ceramic isolator

^{52}Cr - Ceramic isolator after ECRIS operation without hot liner

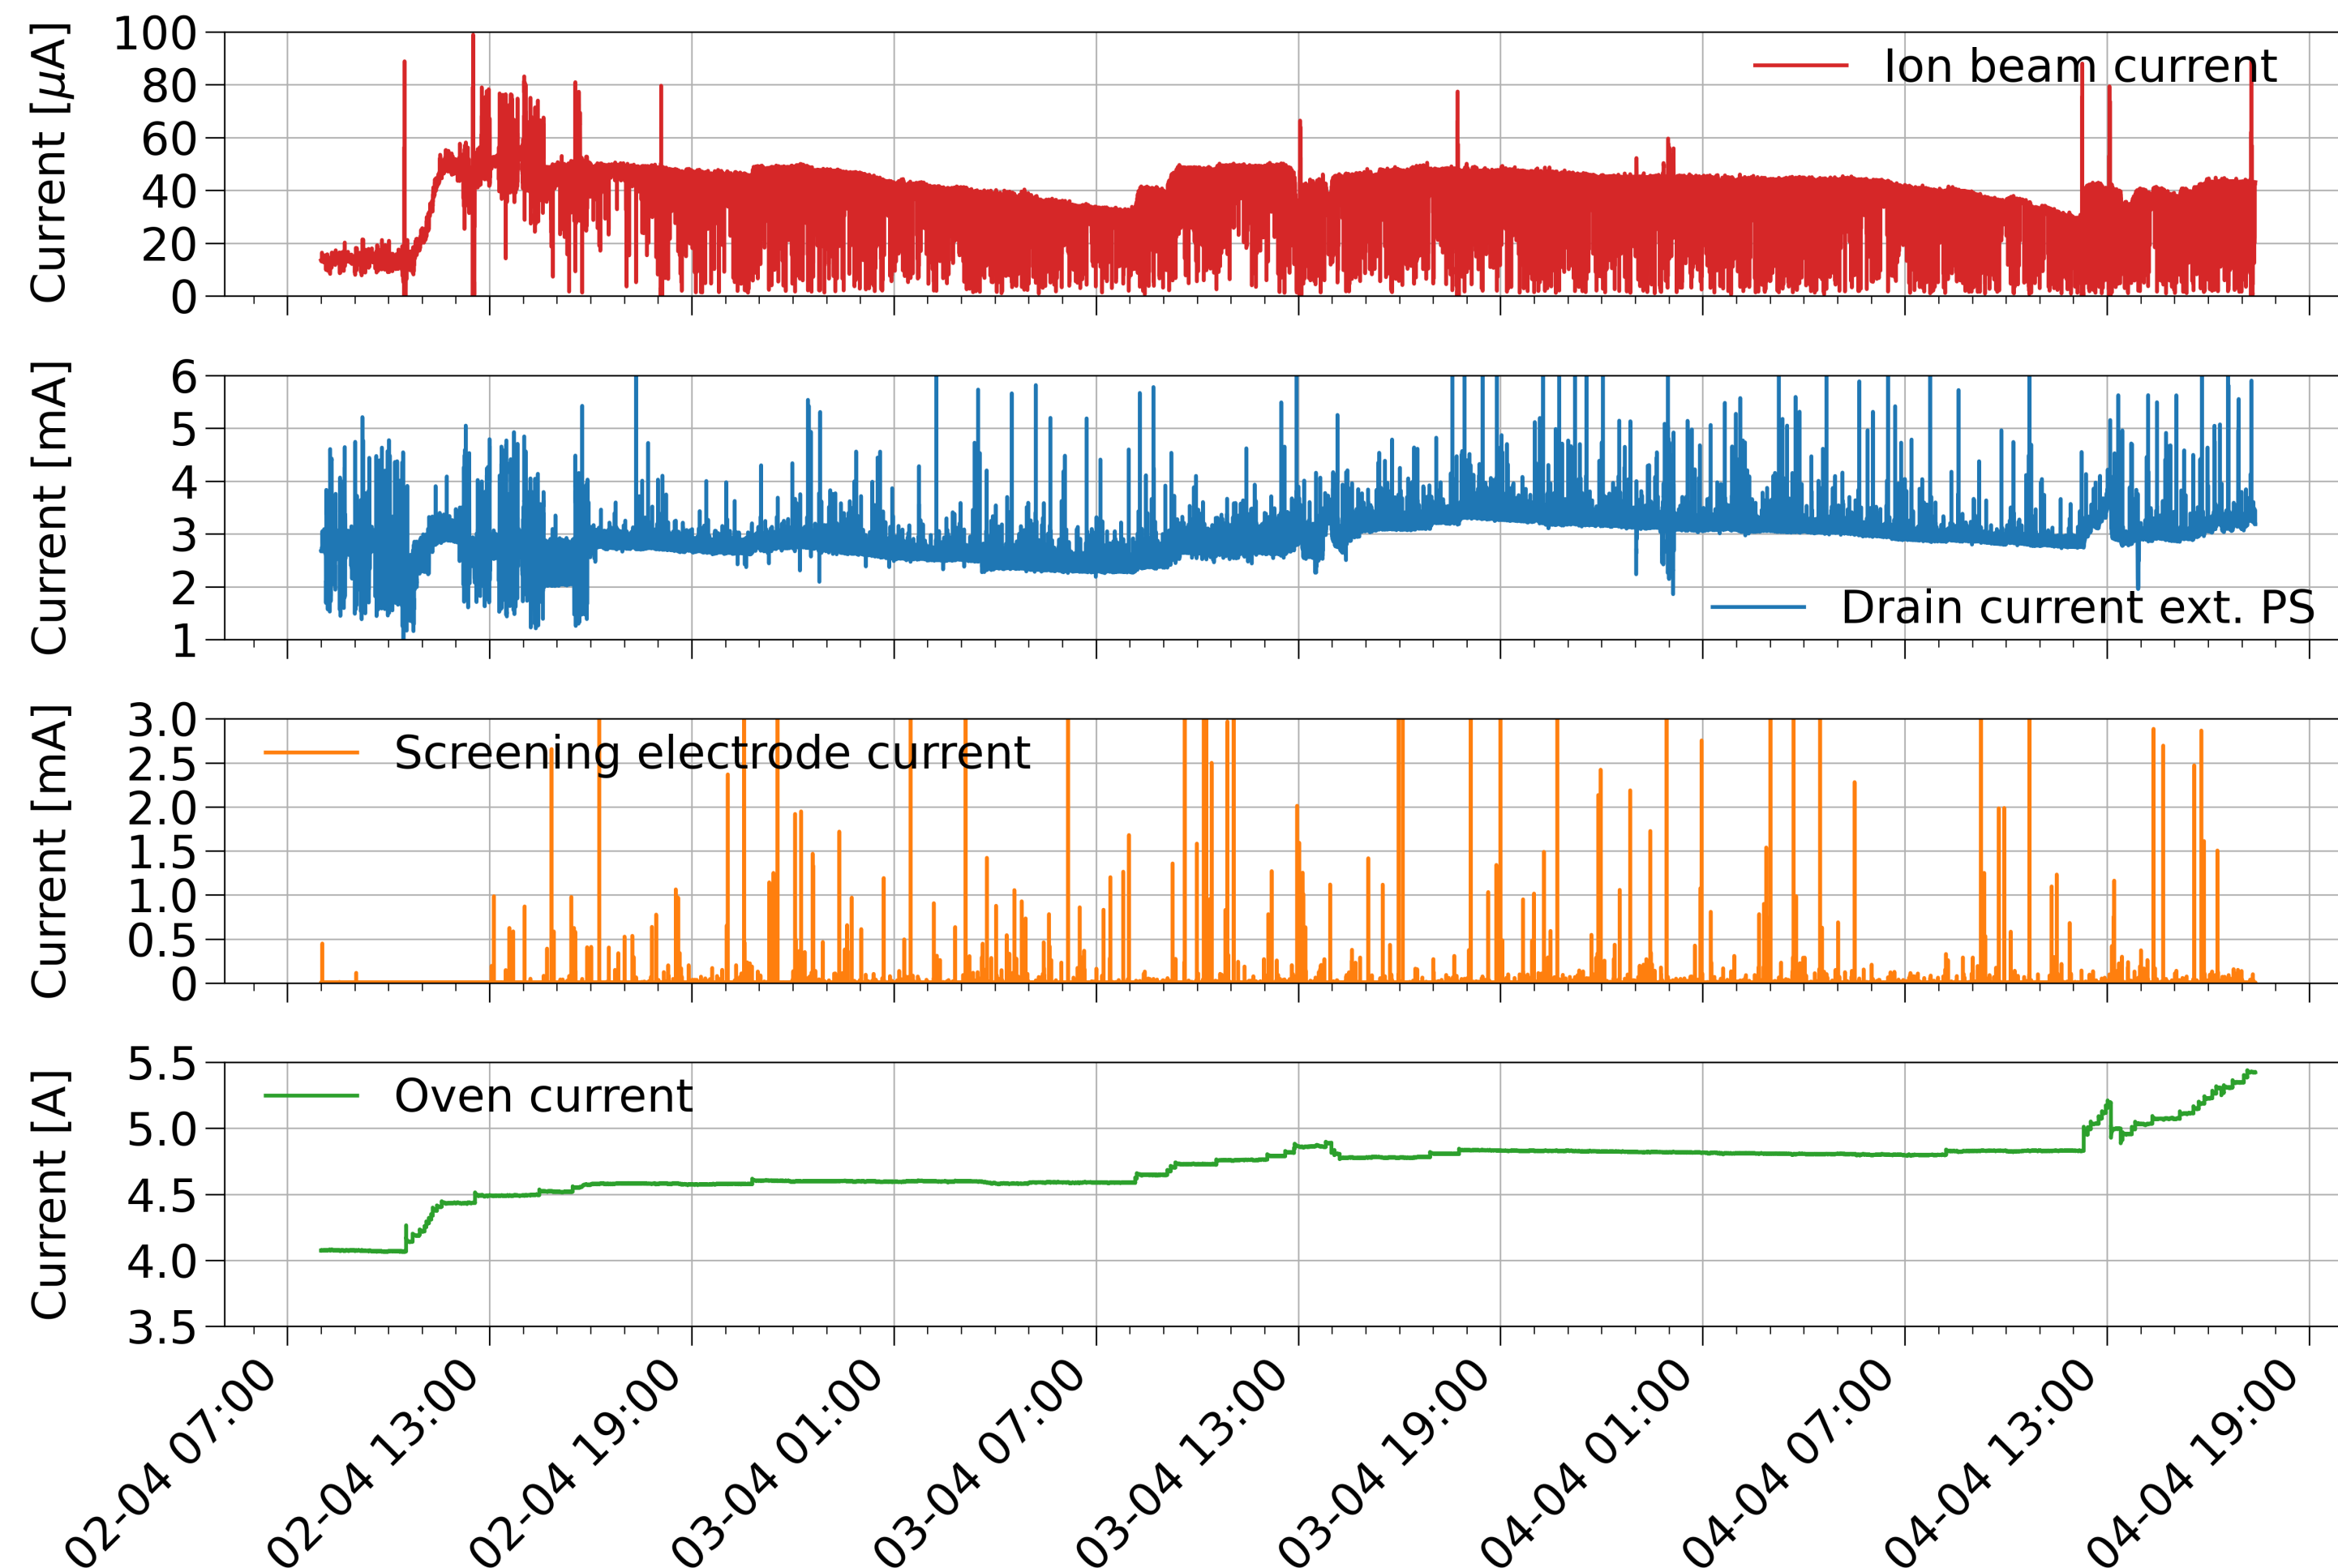
^{52}Cr performance improvement

$^{52}\text{Cr}^{10+}$ intensity, drain current of the extraction power supply, current at the screening electrode and oven current with hot liner (left) and without hot liner (right)

With hot liner:

- No discharges measured at the screening and at the extraction power supplies.
- Improved beam stability
- No visible traces on the ceramic isolator

Without hot liner:
